## **Blackfoot Watershed Revegetation Assessment**

**October 2010**

*Prepared for the Blackfoot Challenge and  
The USDA Natural Resource Conservation Service*

*Prepared by Greenwing Restoration, LLC  
Ovando, Montana*

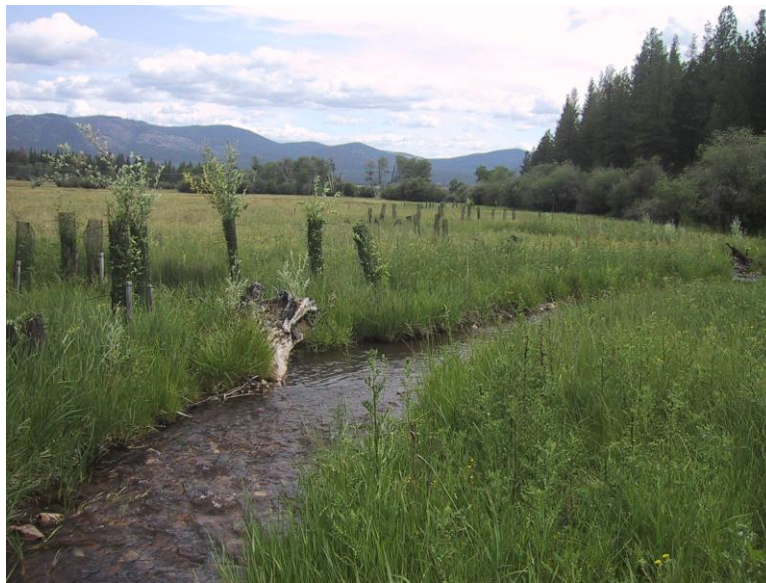
**Photo 1:** Ashby Creek Photopoint 1 at the upstream end of Reach 1, looking downstream towards the Potomac Valley. Note 4 foot tall plant protectors, and vigorous growth of a number of seedlings.

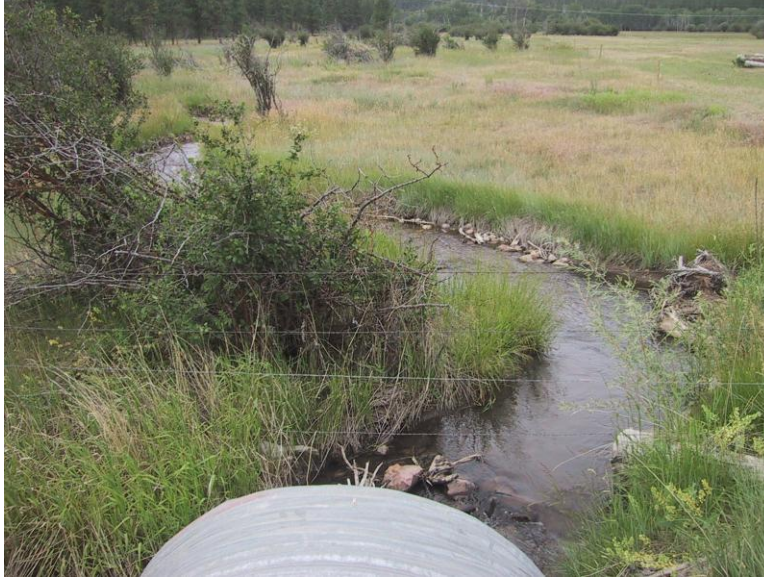
**Photo 2:** Ashby Creek Photopoint 2 at the downstream end of Reach 1, looking upstream from the upper culvert crossing on Ashby Creek. No planted seedlings are visible in this photo.

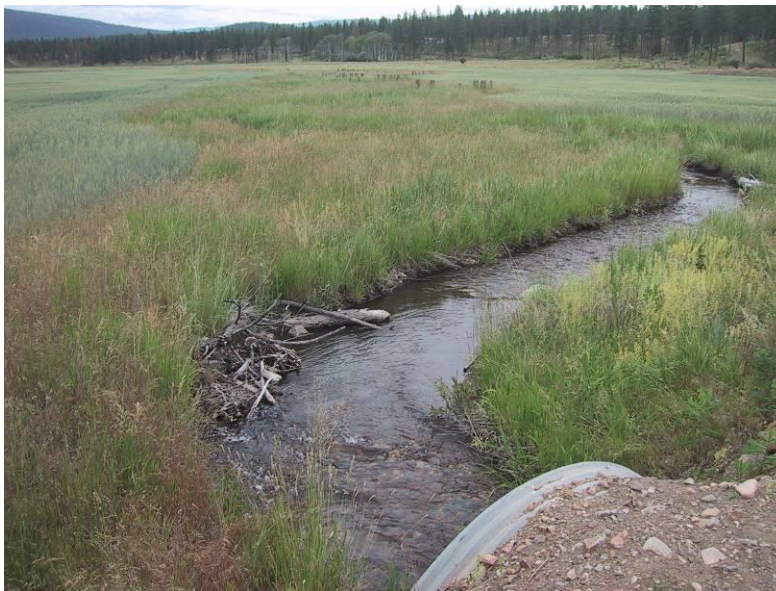
**Photo 3:** Ashby Photopoint 3 at the upstream end of Reach 2, looking downstream from the upper culvert crossing on Ashby Creek. Note the herbaceous cover of annual weeds and tame pasture grasses in the riparian area, and the adjacent farmed area. Seedling planting groups are in the distance.

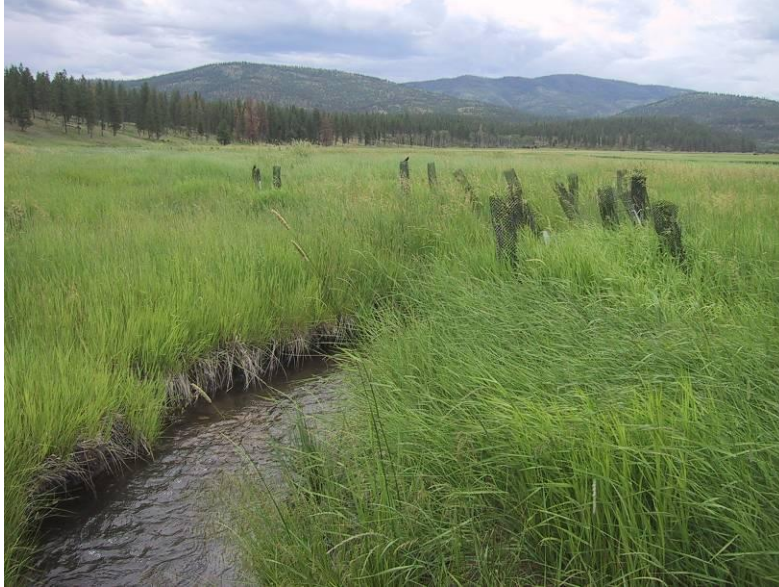
**Photo 4:** Ashby Photopoint 4 at the downstream end of Reach 2, looking upstream from the end of the project. The lower end of the project is subirrigated, as evidenced by the tall stand of Garrison creeping foxtail that appears to be crowding out the seedlings in their black protectors.

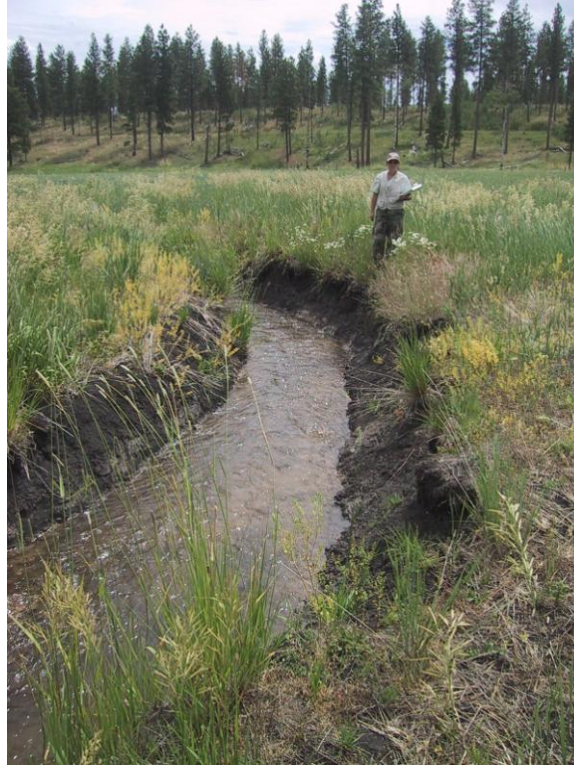
Several project shortcomings became apparent during installation and maintenance (the authors were involved in both of these efforts), as well as during monitoring and evaluation. Many plants were installed with rootballs protruding from plant holes, causing root desiccation, damage and eventual mortality. Some planting locations that were staked during the layout phase, and therefore installed, ended up too far away from streambanks; here plants had difficulty accessing groundwater. The post-project herbaceous plant community in some sections indicates soil and stream water levels are lower than anticipated, in particular at locations where the newly-constructed channel has incised (Photo 5).

**Photo 5:** Incised section on newly-constructed channel. The planting group at this location has all died, and the protectors and mulch mats were removed by maintenance crews. Note vegetation community dominated by upland pasture grasses and annual weeds.

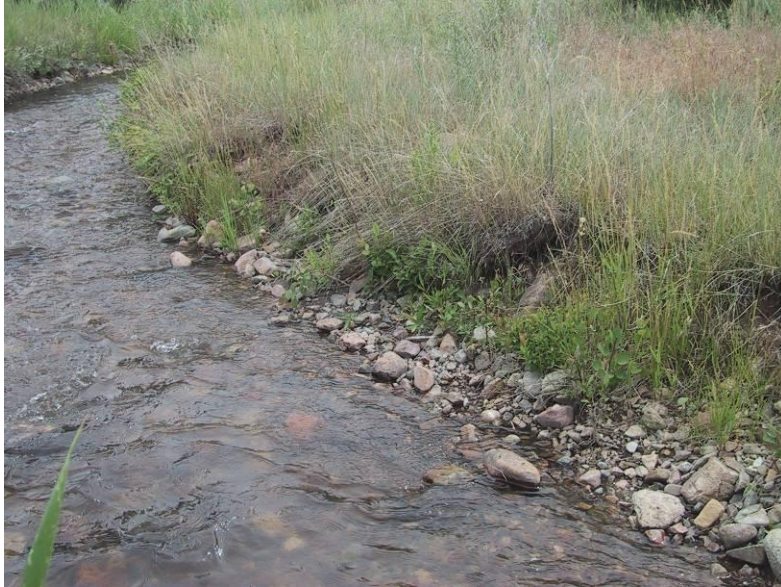
**Photo 6:** Passive regeneration of woody plants along Ashby Creek. Volunteer aspen, willow species, and alder seedlings were observed in large numbers on some banks. As there is ample seed source upstream, it appears Ashby Creek is capable of natural revegetation given time and ideal conditions.

We recommend an additional 2 years of seedling maintenance on Ashby Creek, ending in September 2011. Watering should continue at a minimum twice per late summer (July 15 through September 1). Perhaps this can be achieved by the landowner, through the extension of the existing wheel-line irrigation system on site already. Plant protectors need to be maintained so they do not damage the seedlings. Browse repellents should be applied to the tops to seedlings where they protrude from the protectors. The thin plastic mulch mats will likely be degraded by this time, but weeding around the seedlings will be beneficial. All remaining plant protectors and mulch mats should be removed by September 2011.

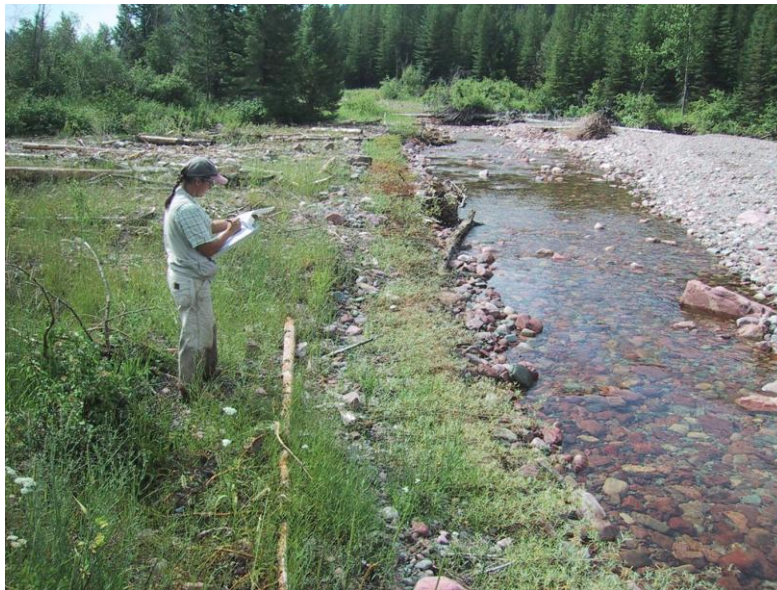
**Photo 7:** Dunham Creek Photopoint 1 at the upstream end of the project, looking downstream. The bank treatment here is a coconut-fiber soil lift, layered with willow whips above and below the wrap. A planting pod is installed in the floodplain to the left.

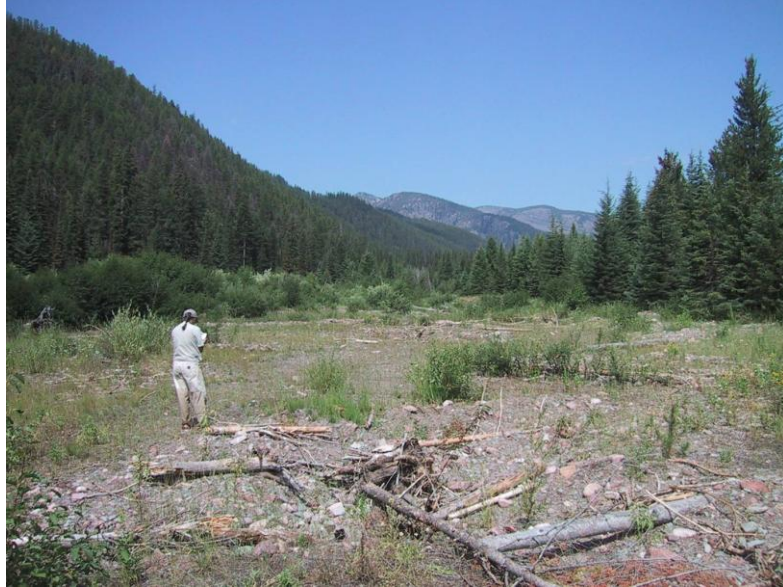
**Photo 8:** Dunham Creek Photopoint 2 at the downstream end of the project, looking upstream. The stream is to the left. A planting basin is installed in the floodplain to the right; behind this is a willow cutting trench. Both features had woody debris scattered over them after planting.

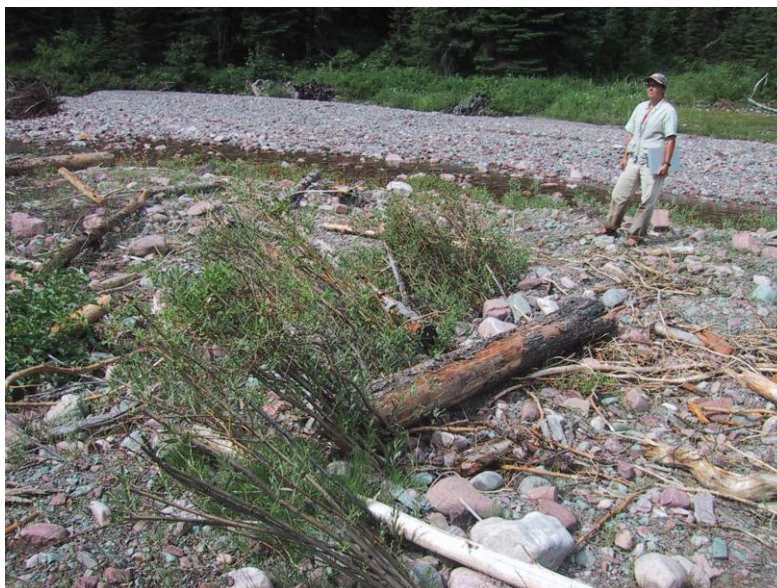
**Photo 9:** Typical “cutting trench”, installed with an excavator and hand crews. A coir log is buried at the toe of the cuttings to aid in water retention at the rooting zone. Note woody debris placed on floodplain; the addition of more debris would further speed vegetation establishment.

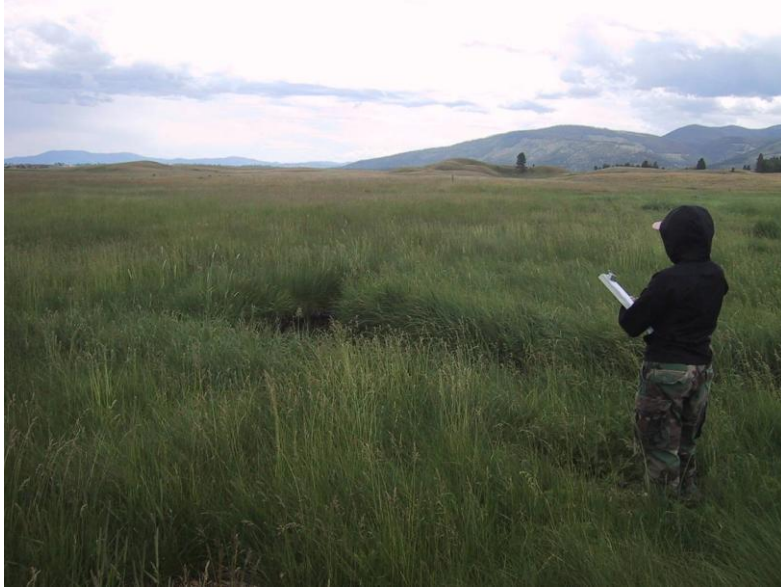
**Photo 11:** Hoyt Creek Photopoint 1, at the downstream end of the project looking upstream. Note dense, tall graminoid cover.

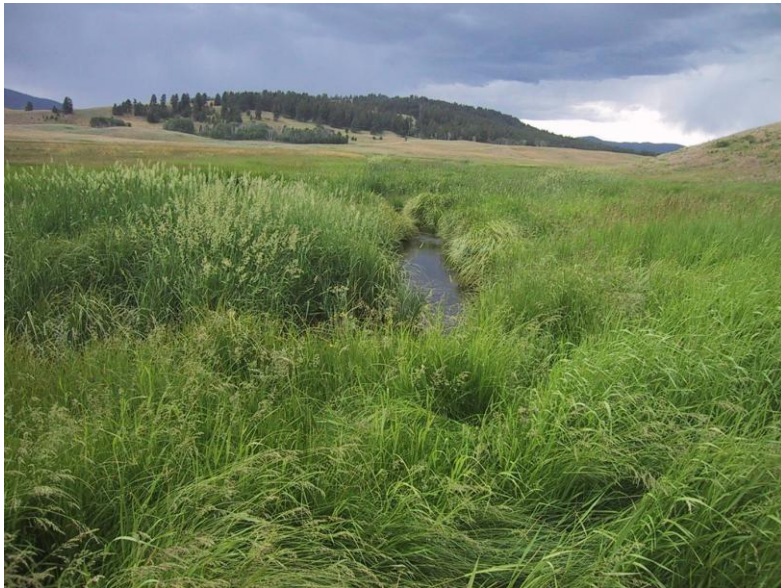
**Photo 12:** Hoyt Creek Photopoint 2, at the upstream end of the project looking downstream. Note dense, tall graminoid cover; there is a shrub planting group on the immediate right.

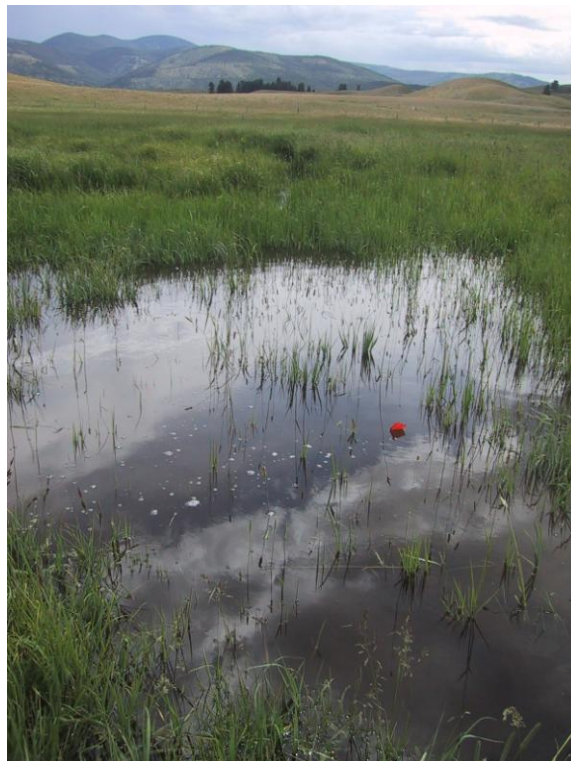
**Photo 13:** Flooded planting group in mid-summer. Flag is at middle of the group. A few seedlings are still surviving, but certainly not thriving under these conditions.

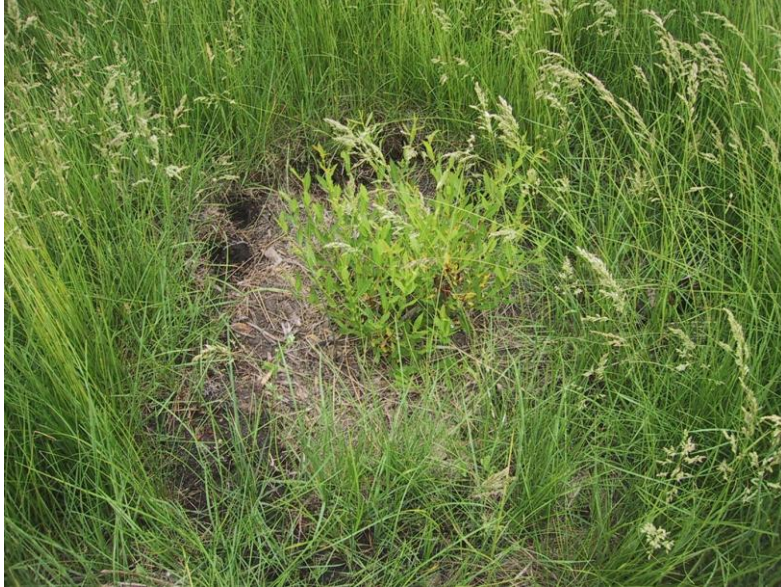
**Photo 14:** Successful pole yard wood mulch ring around Geyer willow seedling, growing in a patch of Kentucky bluegrass. Barring heavy browsing, this shrub will likely become established.

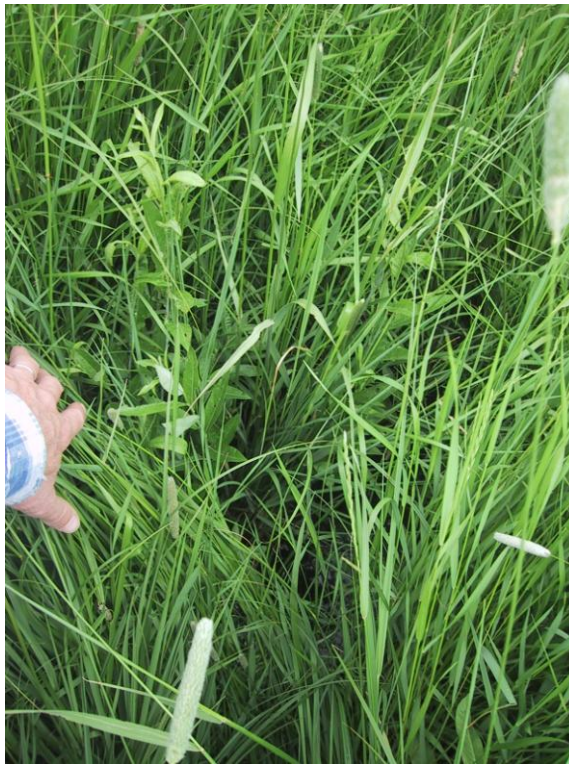
**Photo 15:** Unsuccessful pole yard wood mulch ring around Drummond willow seedling, growing in a patch of Garrison creeping foxtail. Due to the competition, this shrub's chances of survival are questionable.

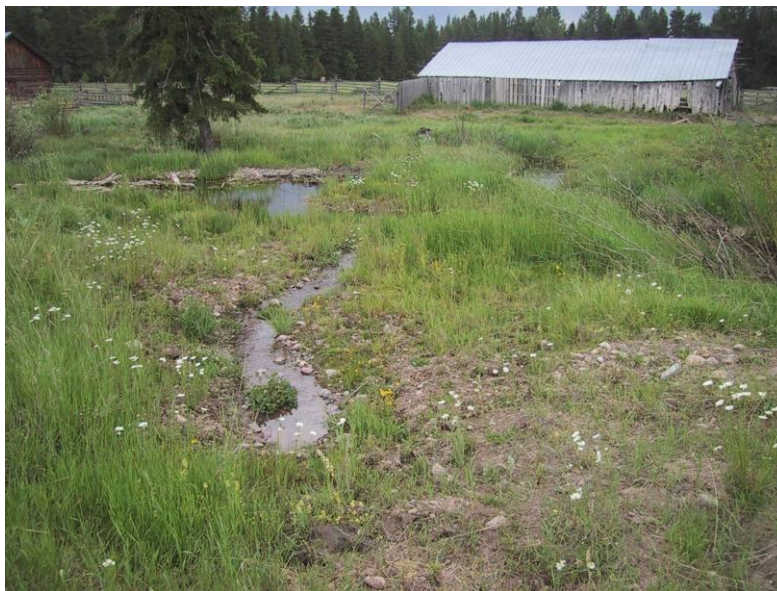
**Photo 16:** Upper Jacobsen Spring Creek Photopoint 1, upstream end looking downstream. Note fresh disturbance from livestock grazing, browsing and trampling on the banks and springhead, and oxeye daisy weed patches. Numerous seedlings are planted in the photo, but are not apparent due to the livestock impacts. Horses were grazing here during monitoring.

Continued livestock grazing will result in increased mortality rates of the seedlings and damage to the establishing streambanks (Photos 16 and 18). Moderate to heavy browsing by wildlife, mostly whitetail deer, is also a plant survival issue. In retrospect, browse nets would have been an excellent investment on this project, considering the high browse potential in this location.

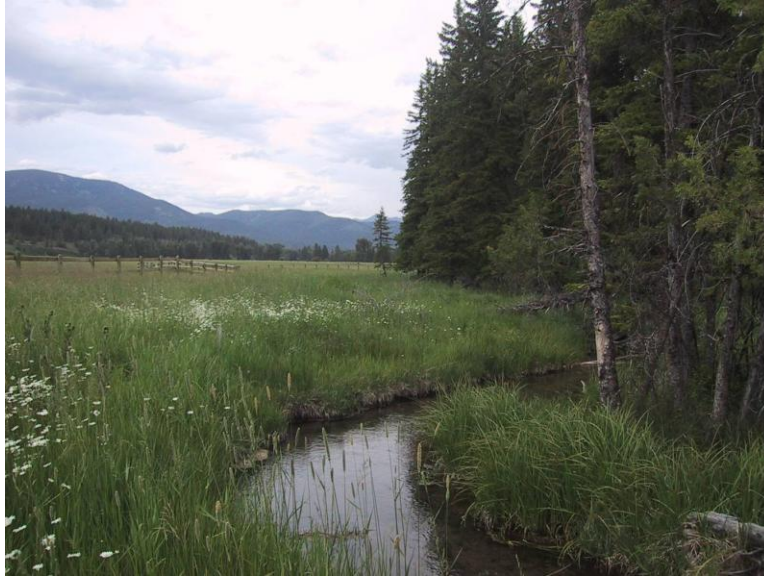
**Photo 17:** Upper Jacobsen Spring Creek Photopoint 2, downstream end adjacent to Highway 200, looking north and upstream. Note oxeye daisy weeds, and ungrazed, stable banks.

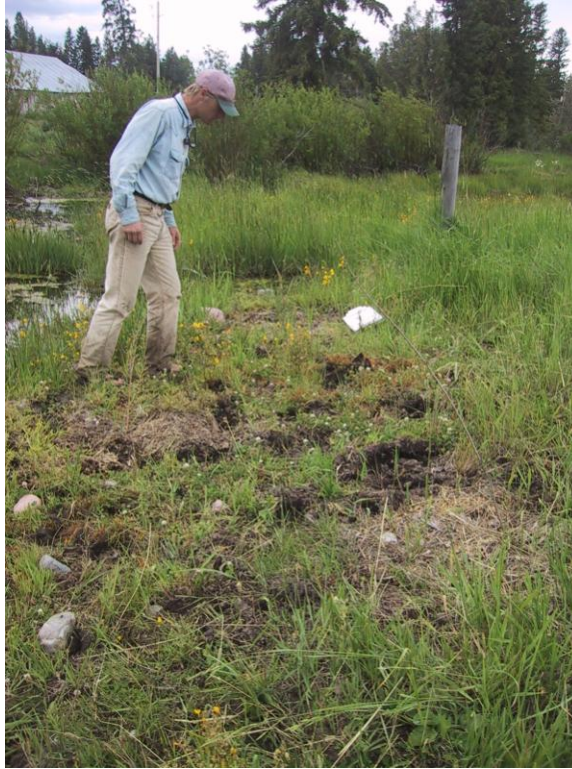
**Photo 18:** Livestock damage near Photopoint 1. Several seedlings (with what is left of their wood chip mulch rings) are barely visible in this picture.

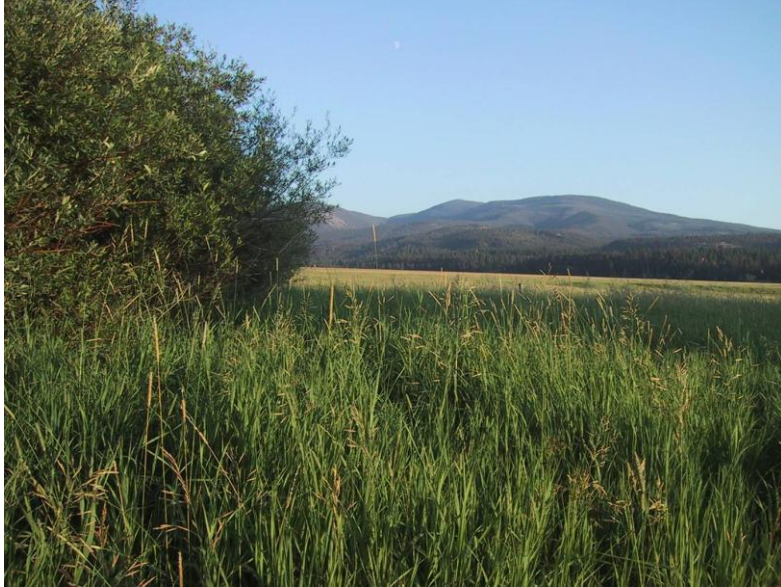
**Photo 19:** Poorman Creek Photopoint 1: Downstream end of project looking upstream. Note riparian area dominated by smooth brome, as well as large established willow on streambank.

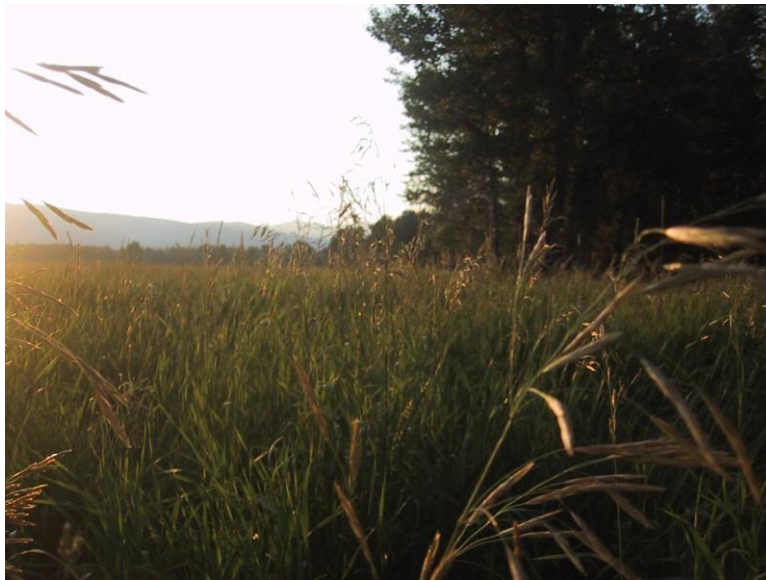
**Photo 20:** Poorman Photopoint 2: Upstream end of project looking downstream. Note height-challenged photographer buried in smooth brome.

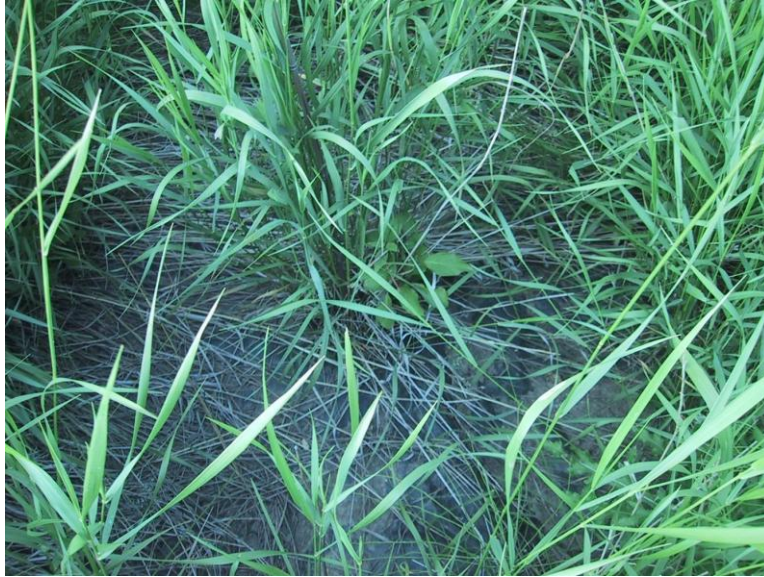
**Photo 21:** Surviving American plum seedling at Poorman Creek. Note tame pasture grass growing through the woven plastic mat. These mats are very difficult to remove from restoration projects due to grass growth. This seedling will almost certainly die from tame pasture grass competition.

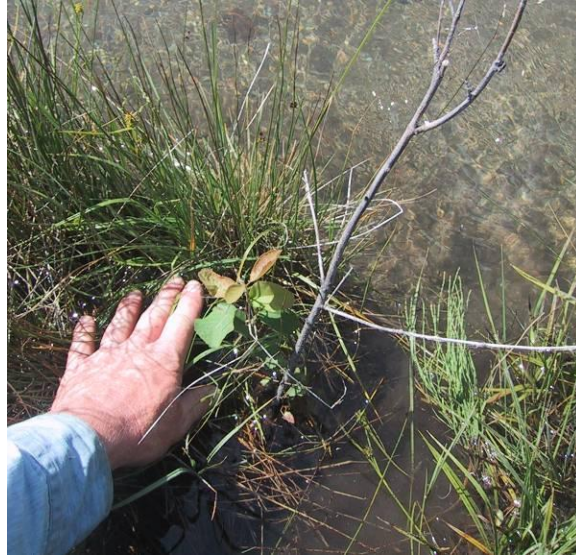
**Photo 25:** Serviceberry growing in water where channel has expanded into bank sods. Note dead plant top, showing original planted size 4 ½ years ago. Note also that this is not serviceberry habitat; serviceberry is an upland plant, and prefers dry slopes, not wetland sites.

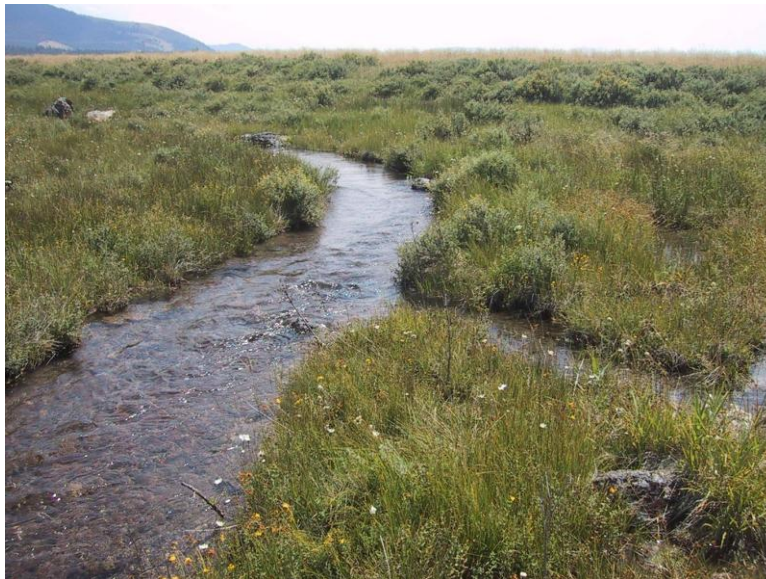
**Photo 26:** Typical stream and riparian community conditions along lower Rock Creek. The protruding sticks are the planted cuttings and seedlings, now principally dead. The living shrubs visible along the banks are naturally-occurring shrubby cinquefoil. Wetland graminoids and forbs dominate the banks and floodplain.

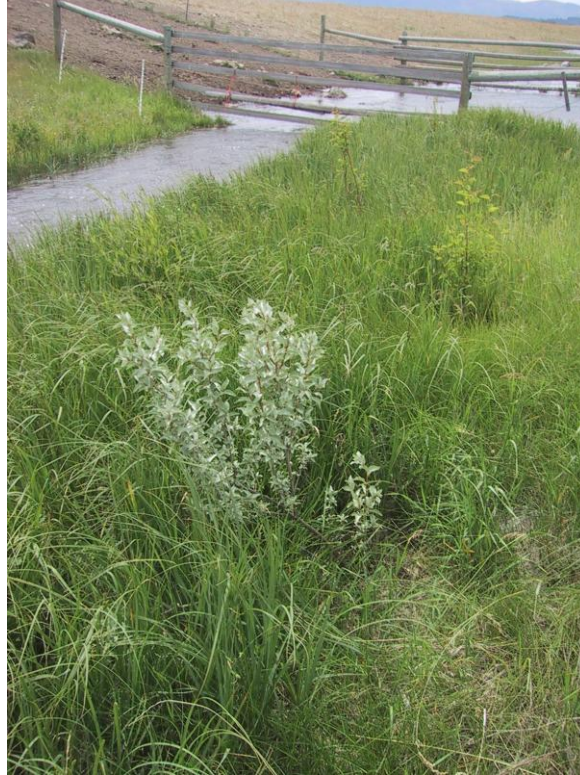
**Photo 29:** Typical seedlings at Middle Rock Creek site. A wolfberry seedling is visible, along with river birch, willow and dogwood behind it. Note grazing impacts on adjacent downstream property; this reach was reconstructed also, but heavy grazing is returning it to an undesirable, over-widened condition.

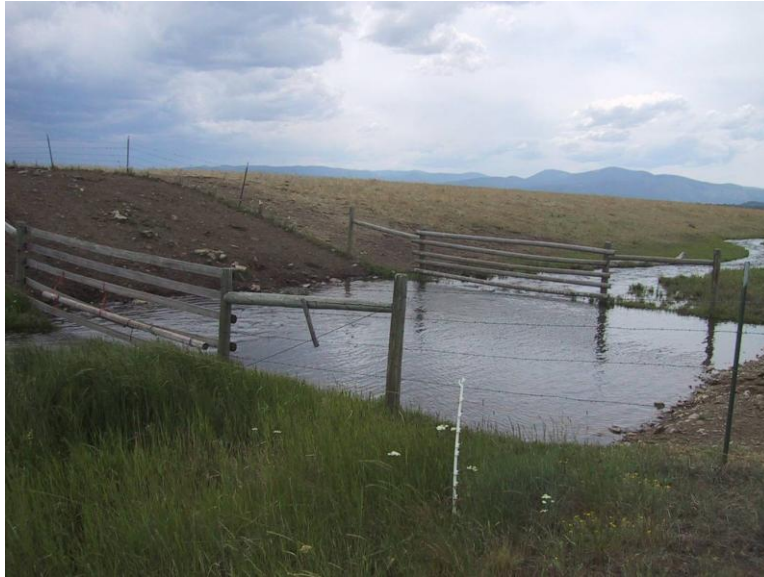
**Photo 30:** View of property downstream of the Middle Rock Creek project. No riparian enclosure exists on that portion of the stream, and the stream channel is markedly wider than on the project area.

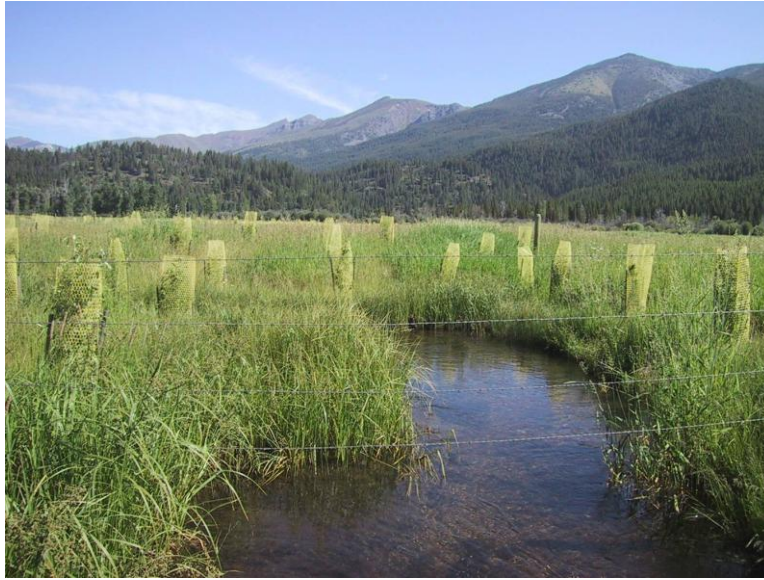
**Photo 35:** Upper Rock Creek Photopoint 2: bottom of Reach 1 looking upstream, from the culvert at the county road. Note heavy grass competition, which is a combination of tame pasture grasses and native wetland graminoids. Also note some plants growing beyond their 4 foot protectors.

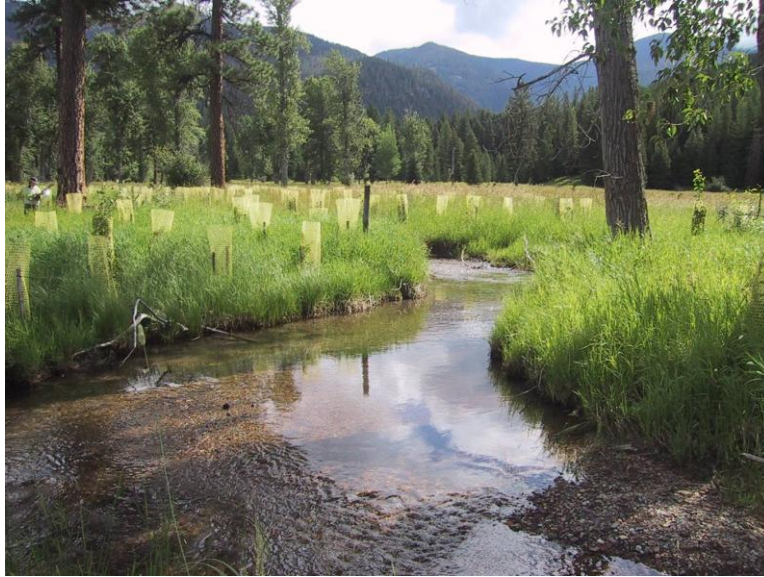
**Photo 37:** Upper Rock Creek Photopoint 4: downstream end of Reach 2 looking upstream. Note eroding bank at furthest upstream point: this extends for hundreds of feet upstream. The banks along this stretch of Dry Creek are higher than the upstream end (Photopoint 3), and are dominated by upland pasture grasses unable to stabilize the banks.

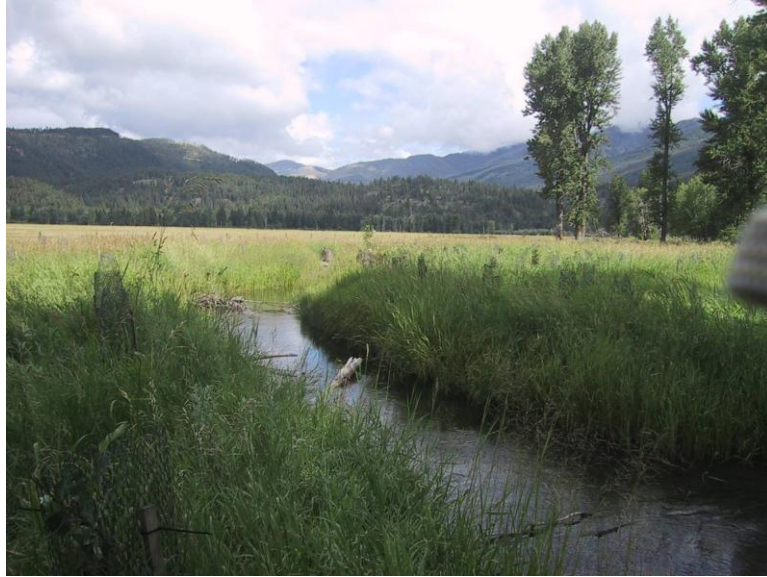
**Photo 42:** Upper Rock Creek Photopoint 6: downstream end of Reach 3, looking up Salmon Creek. Note dense and tall graminoid cover, resulting in a very high competition rating.

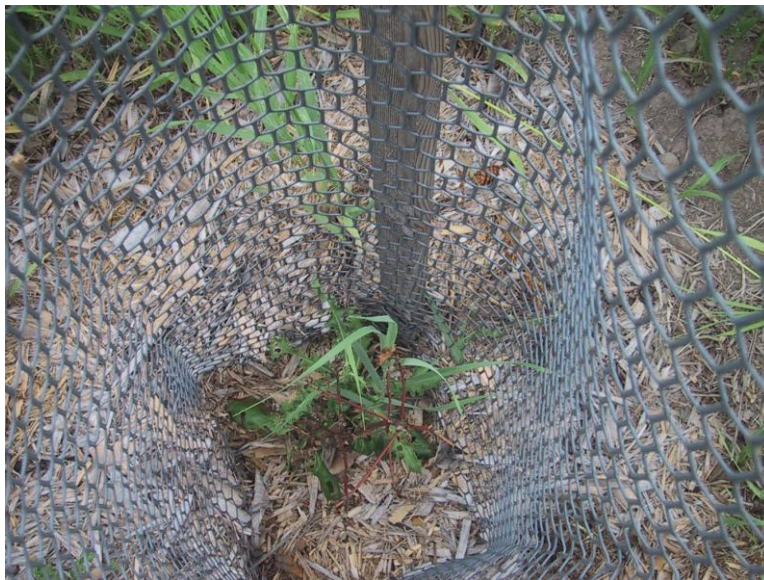
**Photo 45:** Herbicide damage to a dogwood seedling; surprisingly, herbicide was applied inside the protector and on the surrounding mulch. Unfortunately this didn't even kill the target Canada thistle. At monitoring, this seedling (and many like it) were alive and counted as such. However, it remains to be seen if the desired vegetation pulled through.

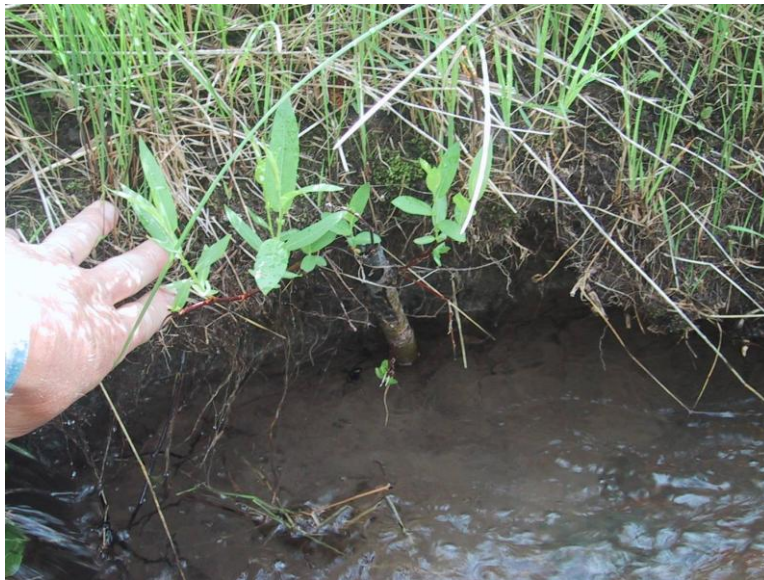
**Photo 45:** Typical surviving willow cutting on Reach 3. At this point, it is unclear whether the plant will establish; the combination of browsing and inundation is a tough hurdle.
