## **Blackfoot Watershed Revegetation Assessment**

**October 2010**

*Prepared for the Blackfoot Challenge and  
The USDA Natural Resource Conservation Service*

*Prepared by Greenwing Restoration, LLC  
Ovando, Montana*

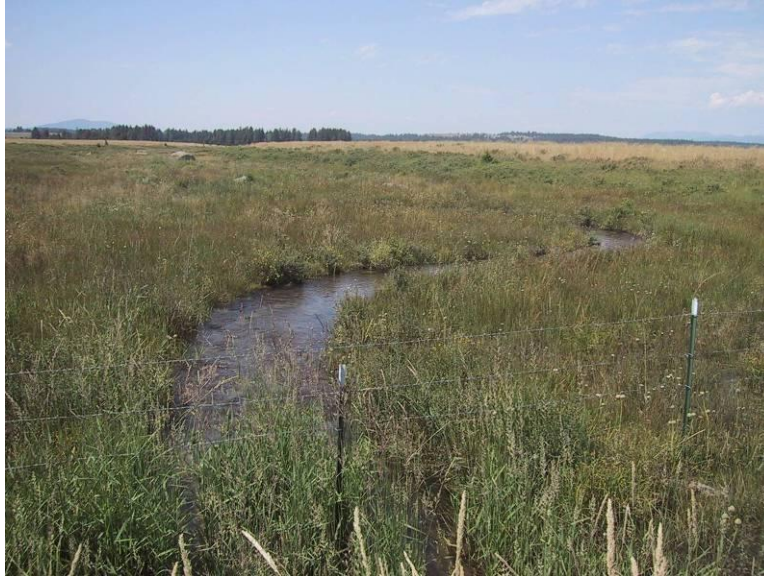
**Photo 23:** Lower Rock Creek Photopoint 1, looking down the South Fork from the county road. Note that the stream is usually dry at this location from winter through spring, with peak flows July through September.

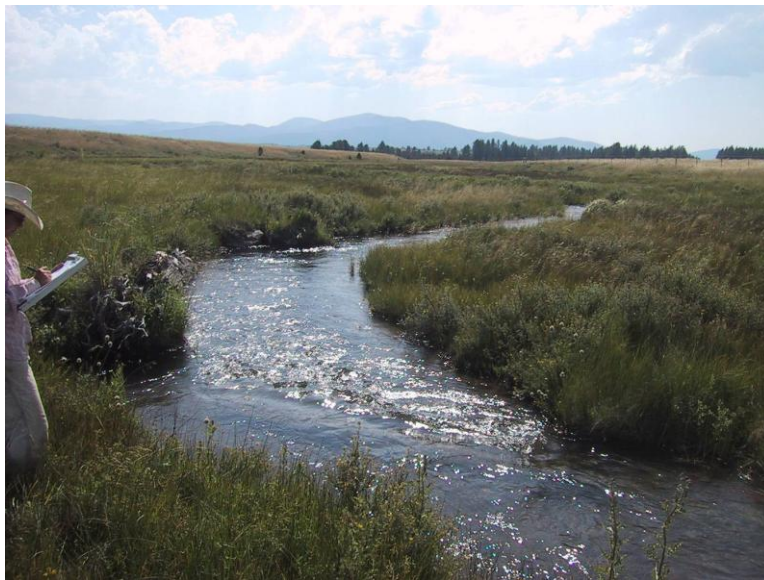
**Photo 24:** Lower Rock Creek Photopoint 4, looking down the mainstem from the county road. This fork also goes dry for much of the winter and spring. Additional photopoints not included here show the same riparian condition: dense wetland herbaceous vegetation with scattered low shrubs, which are mostly shrubby cinquefoil (*Potentilla fruticosa*).

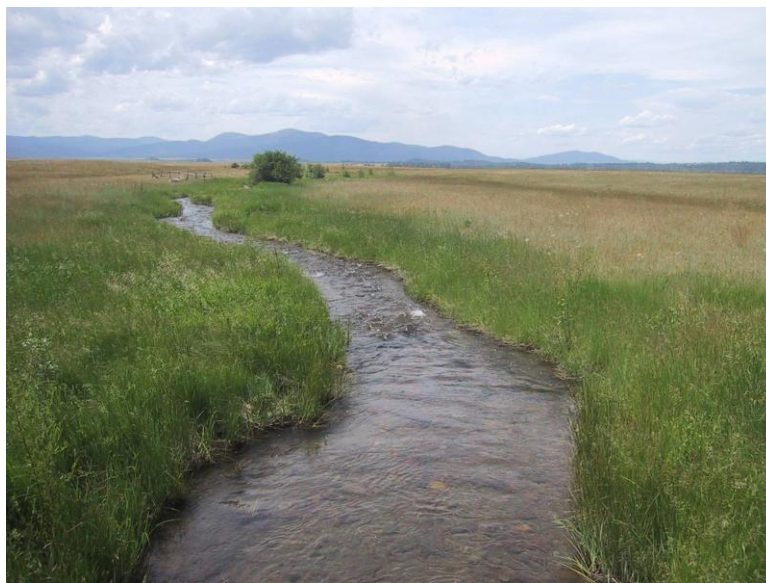
**Photo 27:** Middle Rock Creek Photopoint 1, upstream end looking downstream. Several seedlings are in the picture to the left, but are difficult to see.

The riparian corridor on this project is very narrow (see Photos 27, 28), with an upland shrub/bunchgrass plant community occurring just ten feet or so from the stream's edge. The near bank zone has a healthy and diverse native herbaceous community with minimal weed problems.

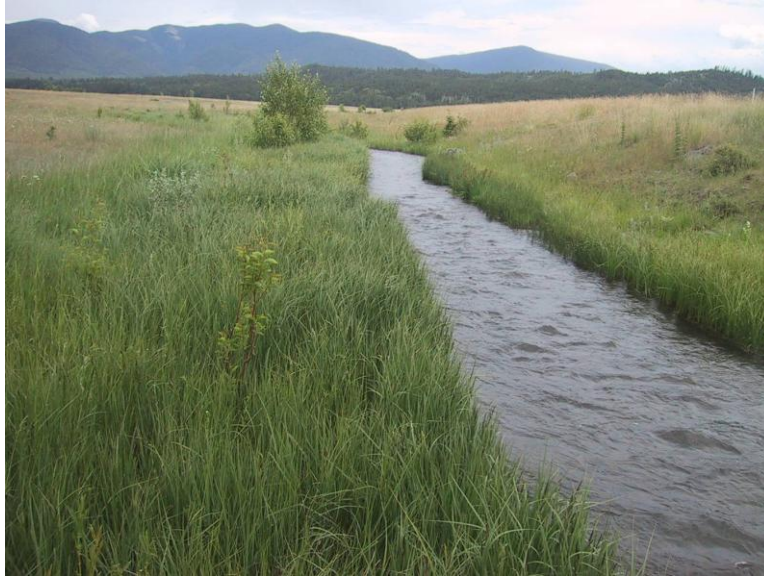
**Photo 28:** Middle Rock Creek Photopoint 2, downstream end looking upstream. Note the redosier dogwood seedling in foreground. Several seedlings are visible behind the dogwood, including a wolfberry.

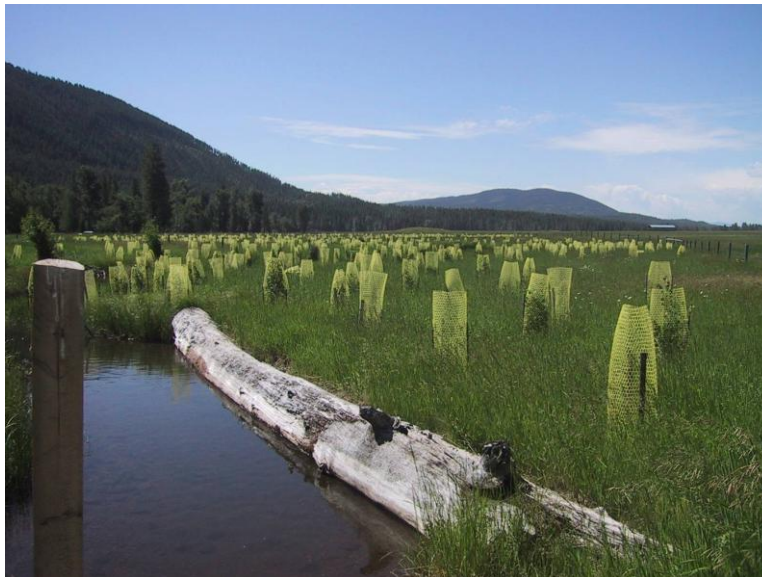
**Photo 34:** Upper Rock Creek Photopoint 1: top of Reach 1 (Salmon Creek) looking downstream. Note old log structure from 1998 rechannelization work by FWS.

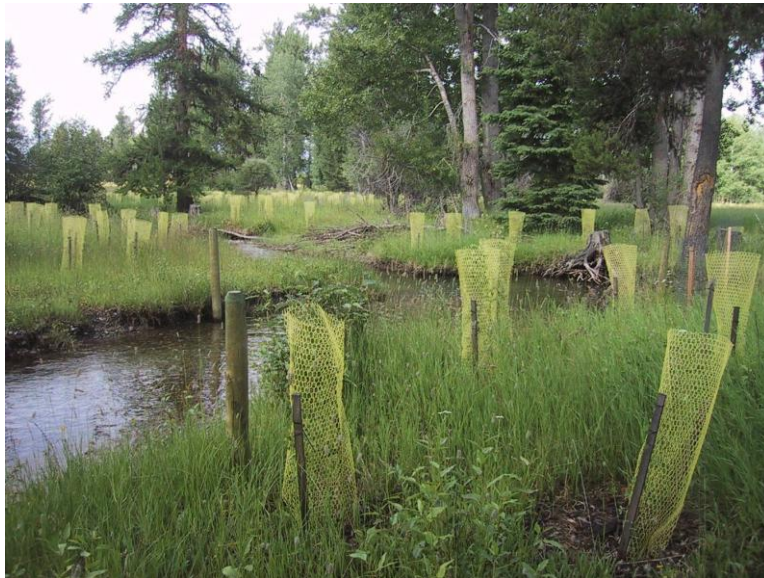
**Photo 36:** Upper Rock Creek Photopoint 3: upstream end of Reach 2 (Dry Creek) looking downstream. This stream typically goes dry by late summer.

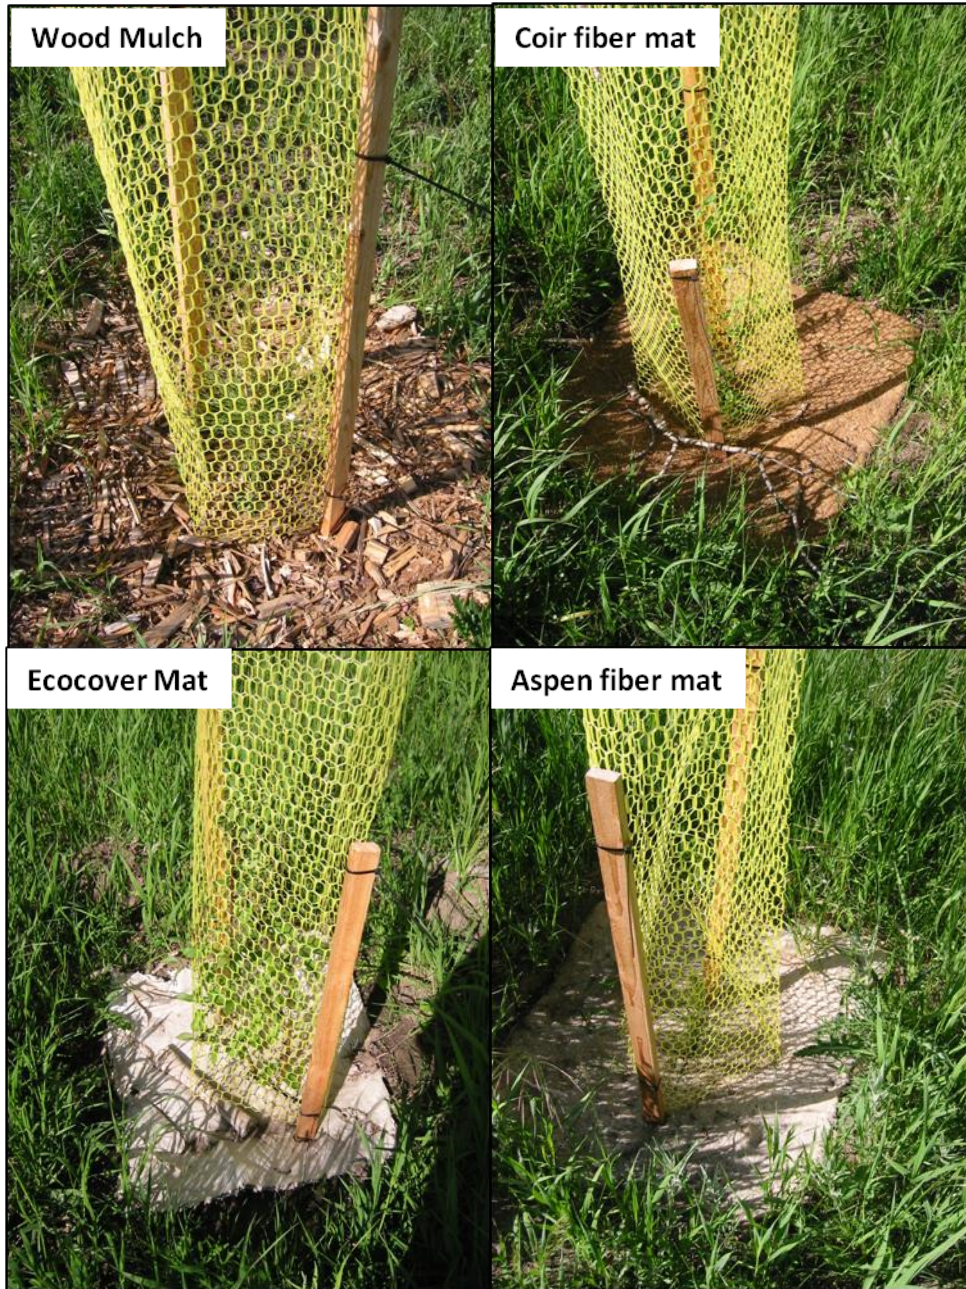
**Biodegradable Mulch Mat Test Plot:** Project managers installed a mulch mat test plot to determine effectiveness of a variety of commercially available biodegradable mulch products. After two and a half growing seasons, we rated the competition from weeds and grasses within the mulch mat on a scale of 1-6, with 6 being high competition. Twenty-five seedlings of each mulch type were evaluated. Results are shown in Table 26. Photos of the mulch types tested are shown in Photos 38 and 39.

The mulch mats were only 25 or 30 inches square, as compared to 36" circular wood mulch applications. Because of the smaller size, and the dense, tall pasture grasses tended to cover the seedlings more, which resulted in a lower rating for the manufactured mats. The mats would likely have performed better had they been larger. However, the woodchip mulch type proved most effective at minimizing weed competition on this site, and also had the added advantages of being (1) locally available, (2) significantly cheaper, (3) easier to weed around the seedling, and (4) suspected vole-deterrent capabilities. Based upon these observations (and confirmed during the monitoring), all of the other projects evaluated here that used wood chips did so because of the URC findings.

**Photo 38:** Biodegradable mulch products tested on Reach 2, Dry Creek. Photos were taken June 21, 2007, approximately one month after planting and installation.

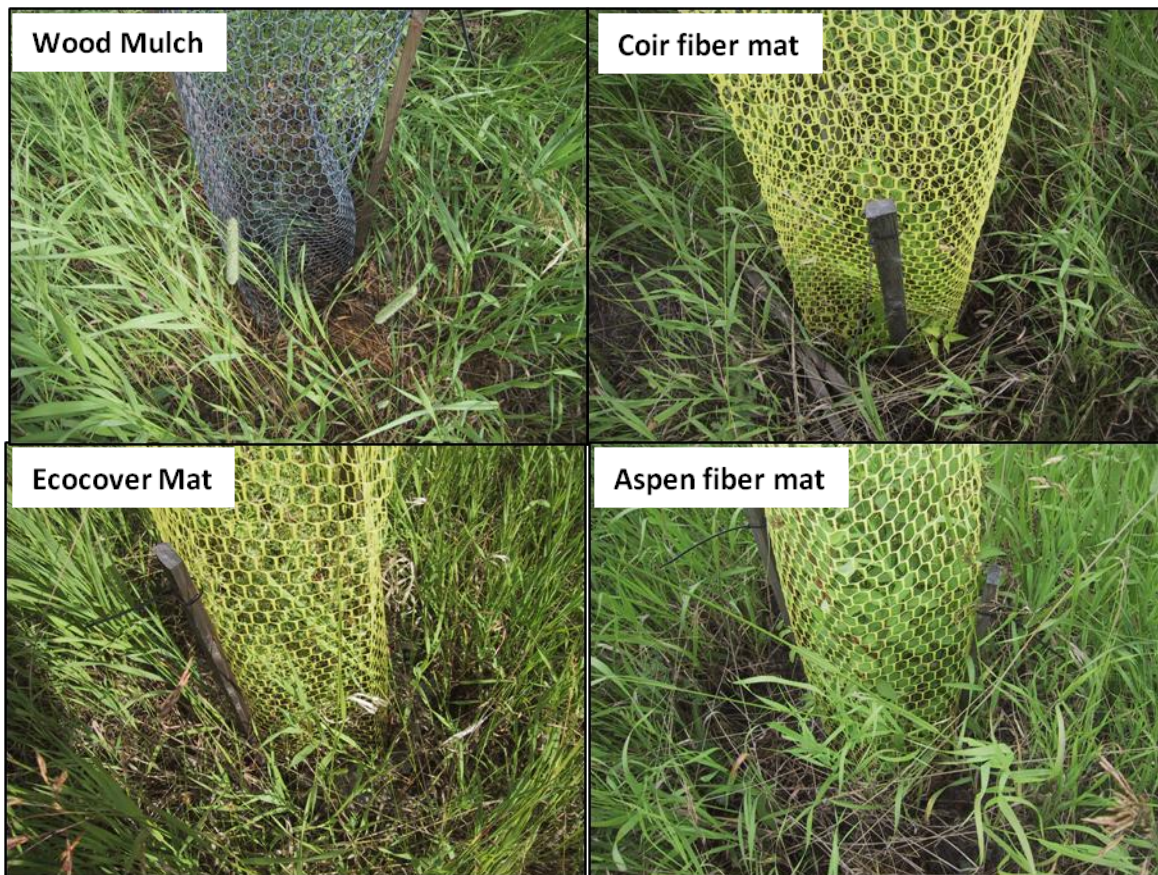
**Photo 39:** Biodegradable mulches, 26 months after installation.

**Upper Rock Creek Recommendations, Reaches 1 and 2:** Plant protector maintenance and browse repellent applications (where the seedlings protrude from the protectors) should continue through 2011, at least twice per growing season. By this time woody plants should be large enough to handle the current level of browse. We recommend that the landowners exclude the still-recovering riparian area from grazing for at least another 10 years.

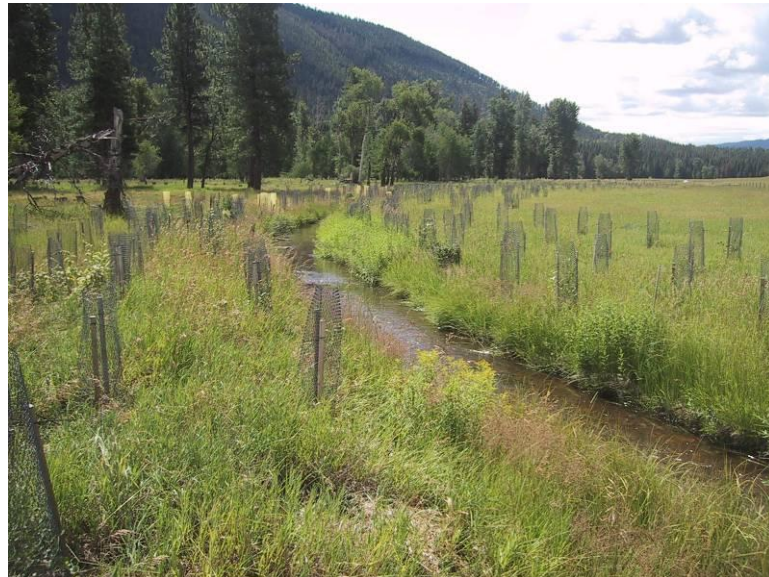
**Photo 41:** Upper Rock Creek Photopoint 5: upstream end of Reach 3 (Salmon Creek from below the county road to the confluence) looking downstream. During channel reconstruction in 1998, this channelized reach was left largely untouched, and therefore is somewhat incised. The remains of the old dike are visible on the left bank; this posed problems for planting close to the stream.

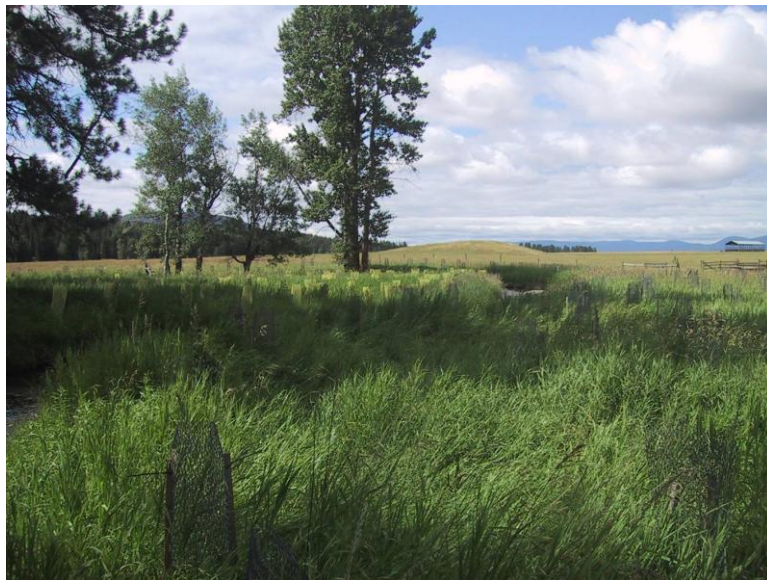
**Photo 43:** Upper Rock Creek Photopoint 7: upstream end of Reach 4, looking down Rock Creek from the confluence of Salmon and Dry Creeks.

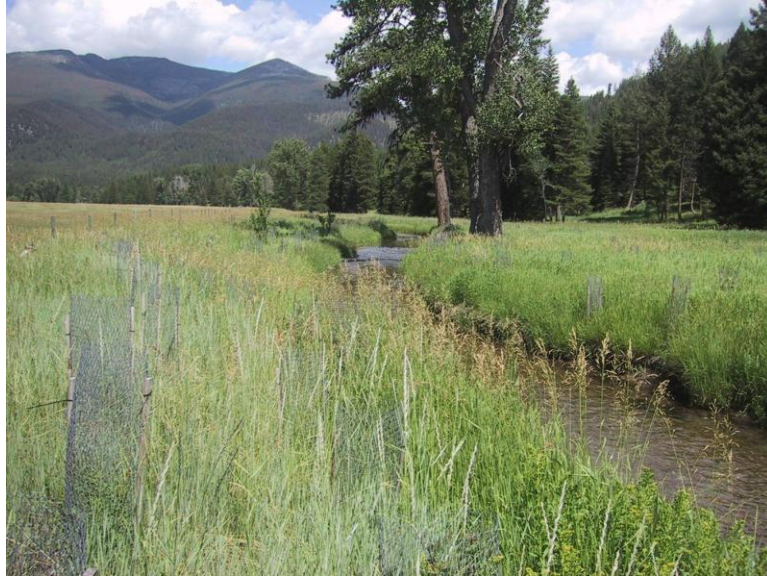
**Photo 44:** Upper Rock Creek Photopoint 8: downstream end of Reach 4, looking up Rock Creek.
